Property Inspection Report  
**KNIGHTSTAR HOME INSPECTION**

**Prepared For:** Sample of a Real Inspection  
(Name of Client)

**Concerning:** Garland, Texas 75044-4620  
(Address or Other Identification of Inspected Property)

**By:** Peter L. Hughes License # 6358 4/10/2009  
(Name and License Number of Inspector) (Date)

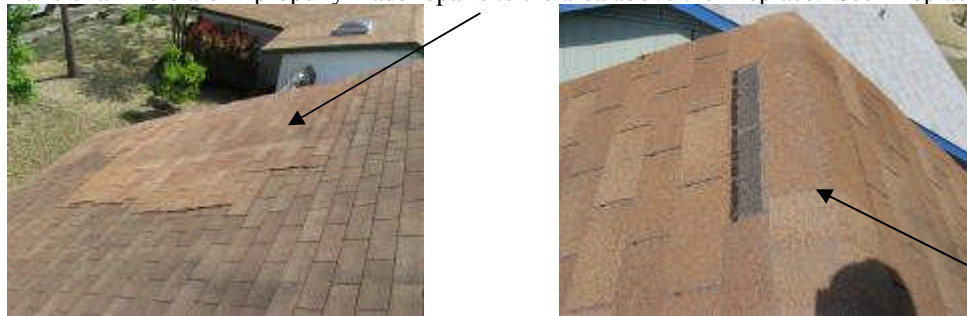
Deficient: There are improperly made repairs to the area above the fireplace. See Fireplace.

The roof is an overlaid roof. In other word 2 sets of shingles. The second set of shingles has many loose shingle tables. There is a large degree of aggregate that is missing. There is exposed fiberglass backing. There are broken/missing shingle tabs. This makes the roof subject to sun and wind damage.

There are loose flashings.

The roofing material over the patio cover is deteriorated. In addition the wood trim in the area above this is loose.

The inspector advises getting a second opinion from a professional roofer. In the inspectors opinion, the roof is at or close to replacement.

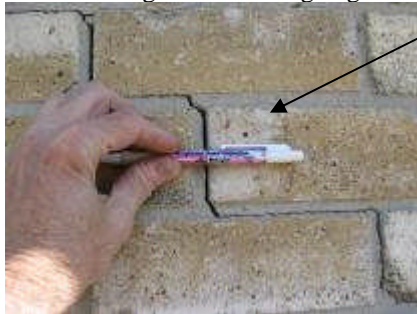
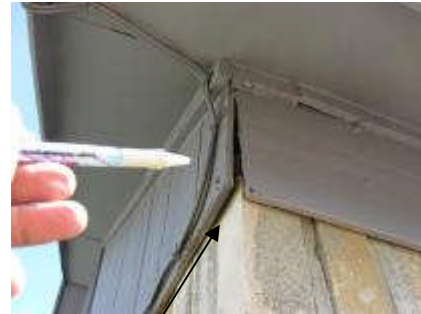
EXTERIOR/: Deficient: There is cracked an separated brick on the back right of the garage. There is separation between the overhead garage doors and the brick. There is separation between the Vertical trim on the right side of the garage and the brick.

There are cracks in the brick on the back left.  
 There is loose brick by the patio doors.  
 There is separation by the freeze boards at the corner of the garage and the back left corner. (These are associated with foundation movement as with the brick cracks.)  
 There is cracked brick by the kitchen window.  
 There is separation between the kitchen & dining room windows and the brick.  
 There are loose bricks in the area of the kitchen window.  
 There is deteriorated wood trim on the over head garage doors.  
 There is separation in the gable siding on the right side above the area of the electric meter.  
 There is missing wood trim around the right side upstairs window and it appears the window is held in with caulk or silicone.

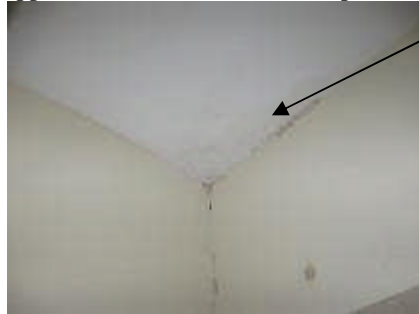
CEILINGS/: Deficient: There is evidence of past ceiling repairs above the downstairs bathtub. This appears to have been related to past water leaks from the upstairs bathroom.

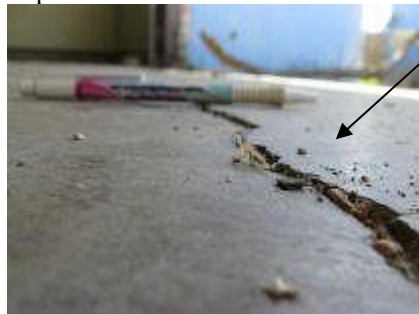
FLOORS/: Deficient: As mentioned previously, the garage floor is cracked and the cement is displaced.

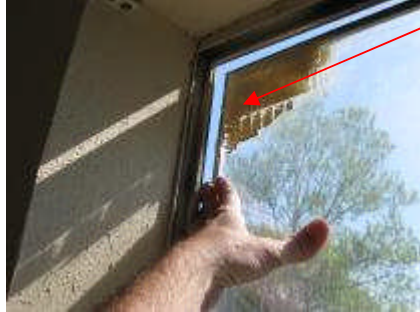
Deficient: The kitchen window appears to have a deteriorated thermal seal.  
 The windows lack screens.  
 The upstairs right bedroom window is fogged.  
 The upstairs left bedroom window is loose and fogged.

The dining room window does not lock! (NOTE: the house is not secure)  
 The front sliding window in the family room will not properly slide.

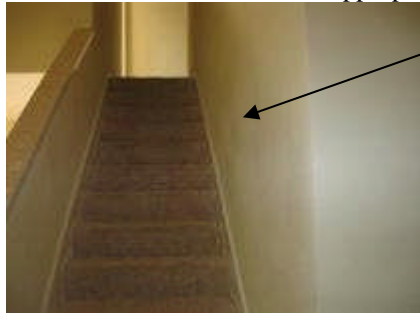
Deficient: The stairs lack and appropriate handrail

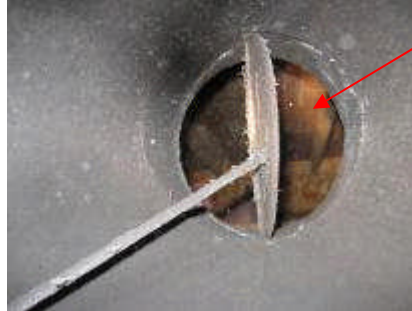
**Deficient: The fireplace is a severe danger to the house and the occupants.**

The fireplace lacks a chimney and chimney flue.

**Very dangerous situation!!!**

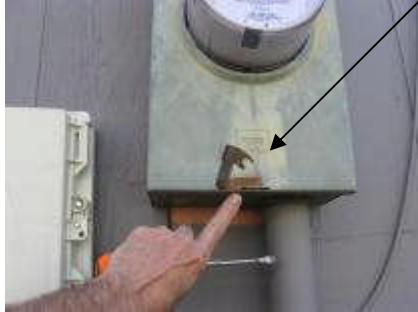
The electric meter cover is normally secured with a seal. The seal was not in place. This leaves the question as to how the power was turned on. In addition, the cover is not secure and can be a potential danger.

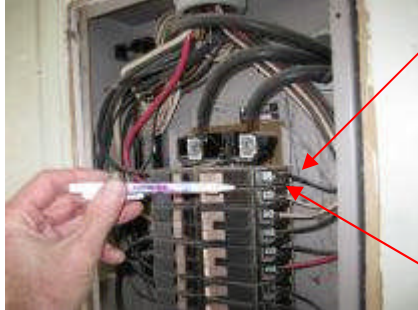
The Air conditioner (AC) condenser (outside unit) is listed as requiring a maximum breaker of 25 amps and the breaker is listed as 40 amps.

The conductor for the AC is rated at 30 amps and the breaker is a 40 amp breaker.

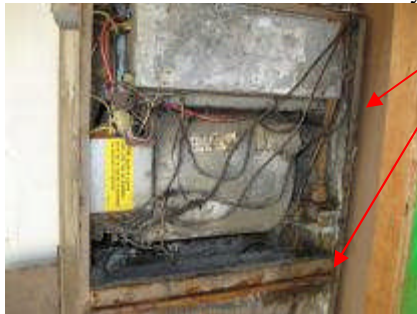
Deficient: The interior of the HVAC system is very dirty.

The unit lacked a filter.

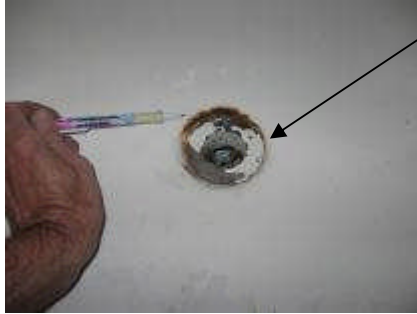
Deficient: The downstairs hall bath sink lacks a stopper and sink does not drain.  
The downstairs bathtub is rusted by the drain and lacks a stopper.

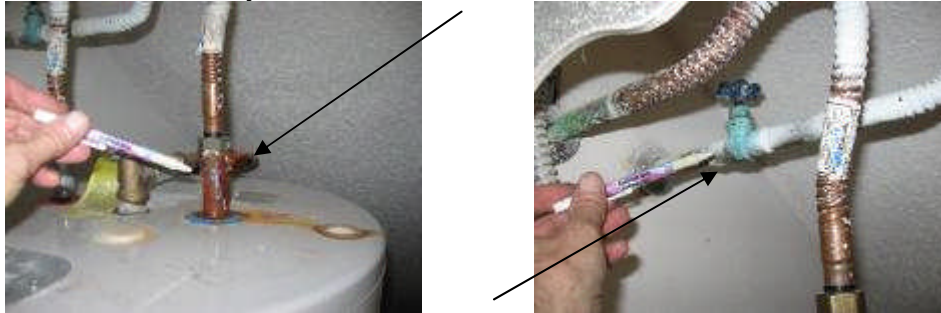
Deficient: The water heater is not functioning. It was noted that the heat element covers were not screwed on?

There is a water leak by the cold water inlet.

The shut off does not appear to be an appropriate type of shut off and the shut off is leaking.

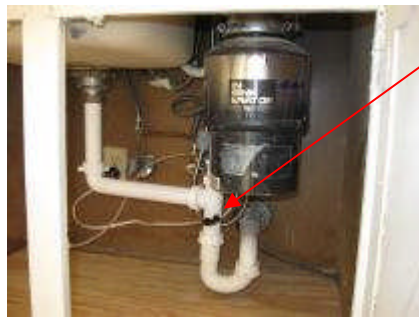
Deficient: Improper electrical wire and connection to the unit.

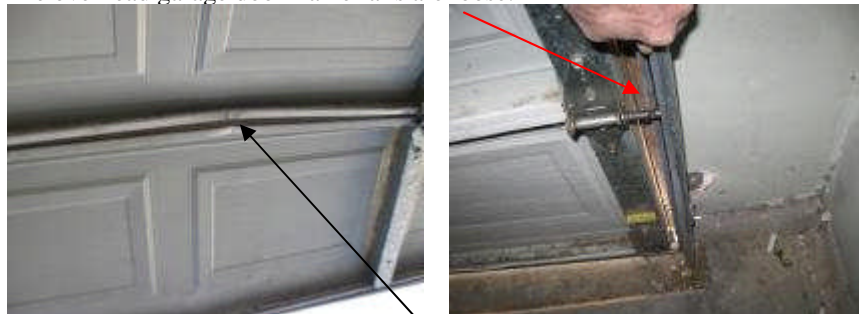
Deficient: The garage door opener is disconnected and not tested.

The overhead garage door frame rails are loose.

The overhead door has 2 damaged panels.
